Aircraft Accident Report

SILKAIR FLIGHT MI 185

BOEING B737-300

**Investigation of Aircraft Accident
SilkAir Flight MI 185
Boeing B737-300, 9V-TRF
Musi River, Palembang, Indonesia
19 December 1997**

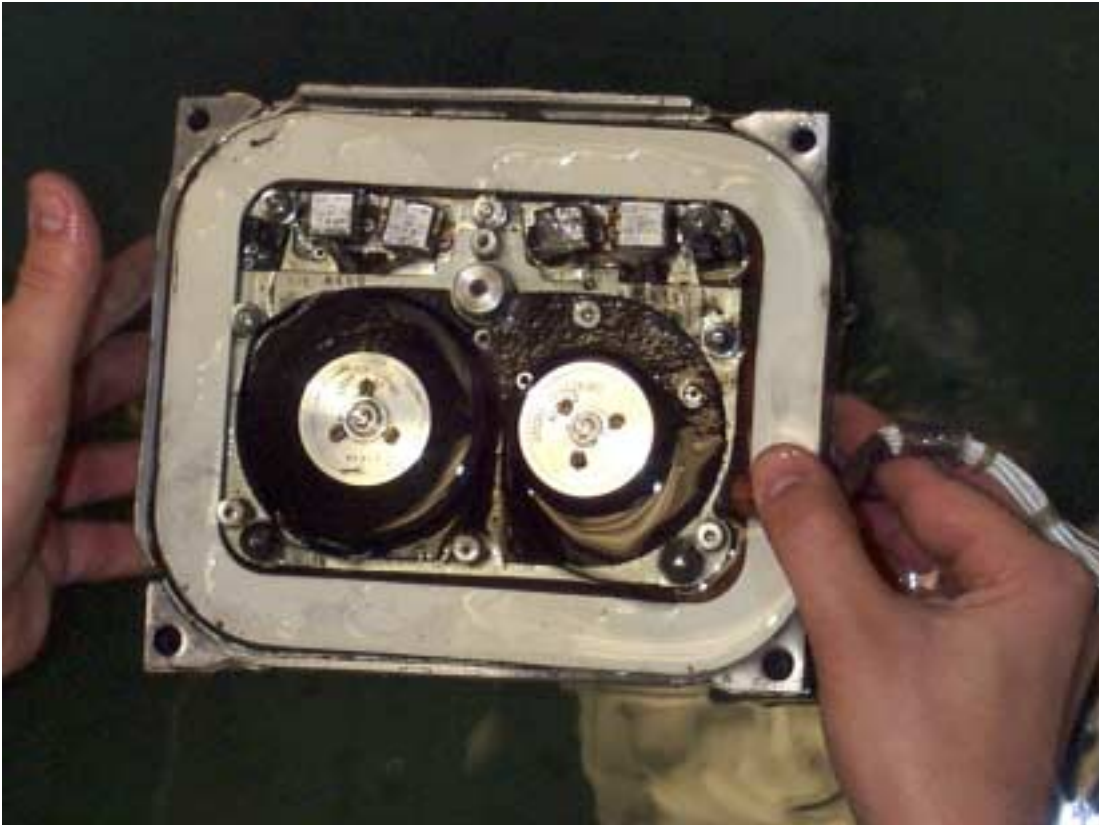
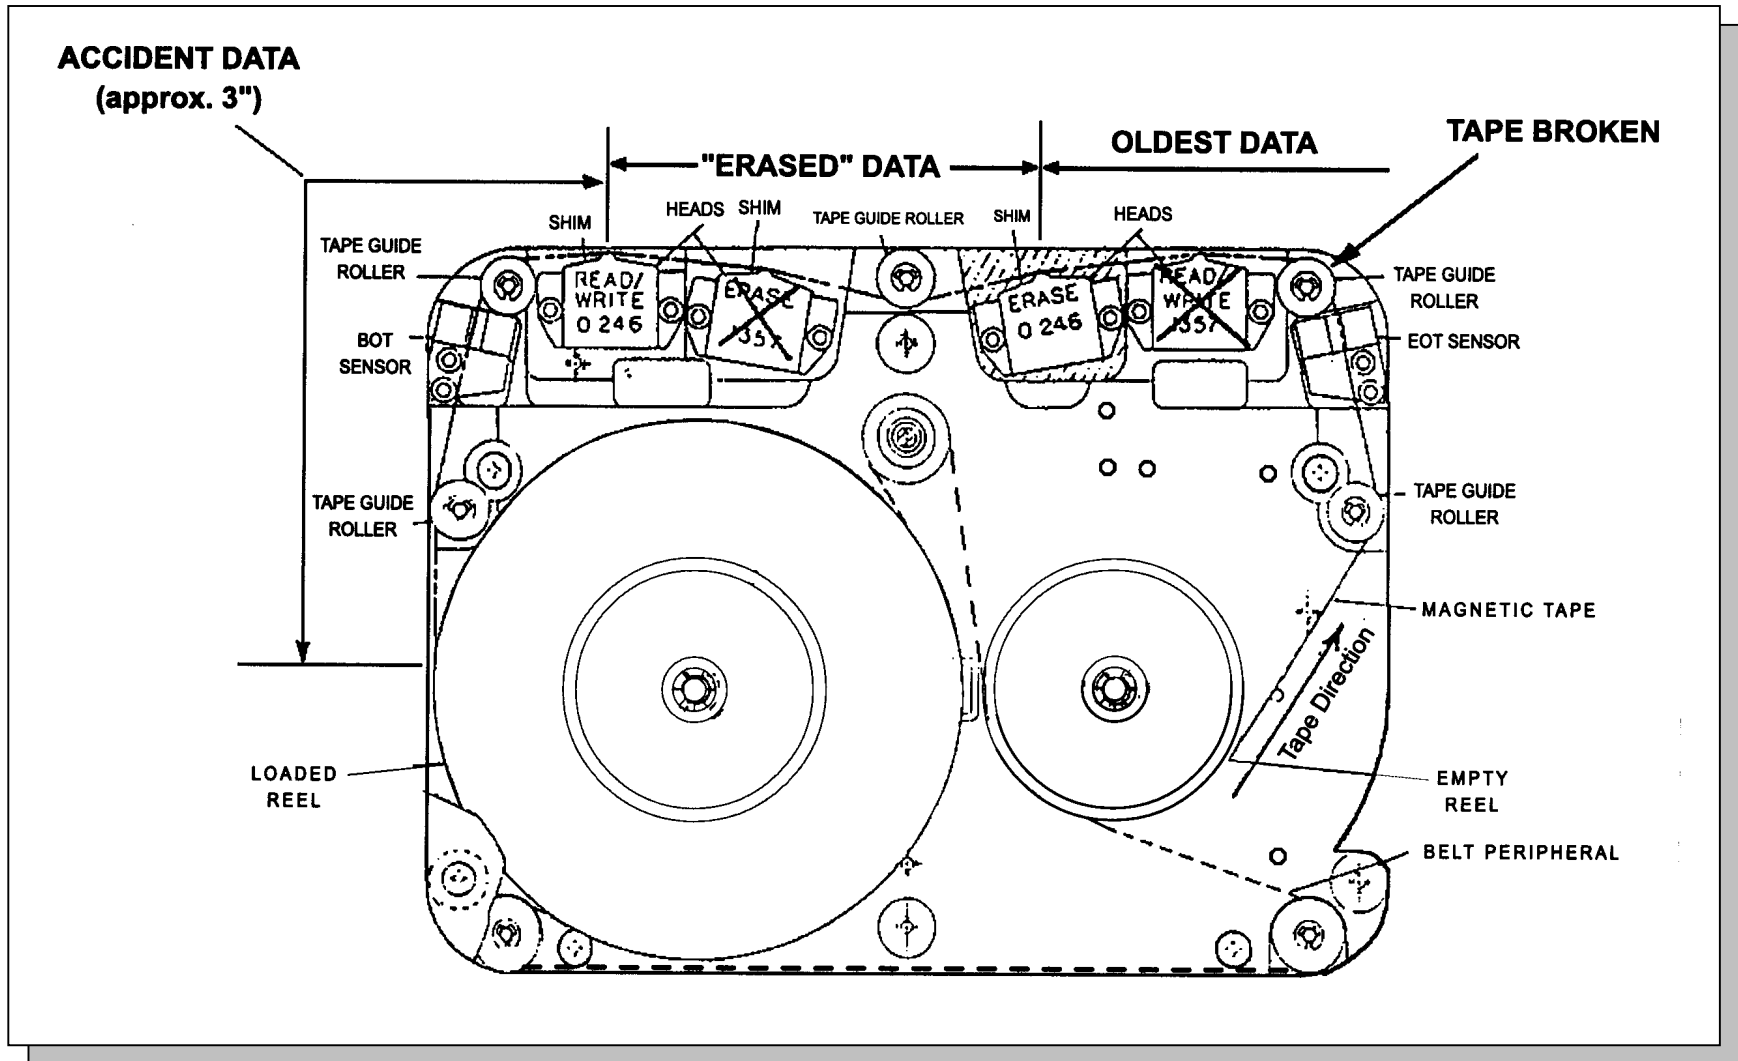
The FDR module was recovered by divers on 24 December 1997. The FDR's underwater locator beacon (ULB) was found detached from the FDR at the accident site. Two of the enclosure's four retaining bolts were broken. The enclosure was partially opened (Figure 4.a). The partial opening exposed the tape between the two tape reels, near the write and erase heads, see Figure 4.b and c.

Figure 4.b The tape inside FDR

Figure 4.c Sketch of FDR tape layout

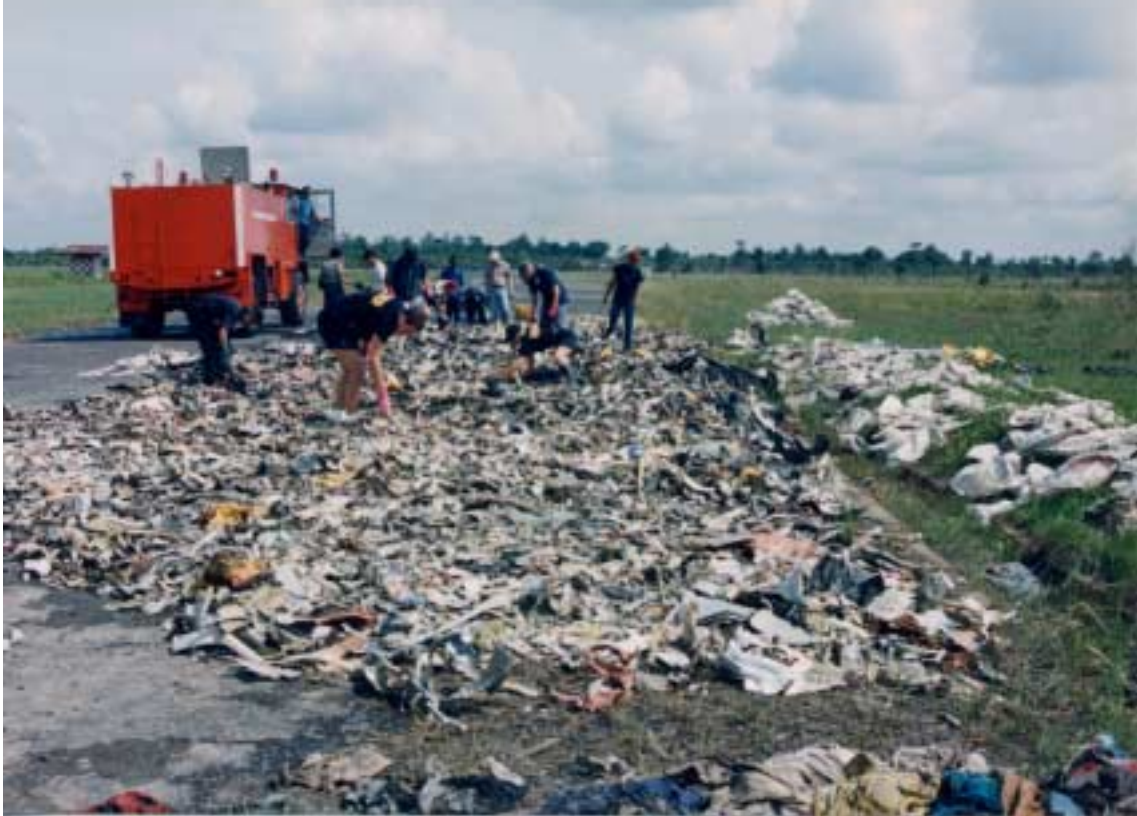
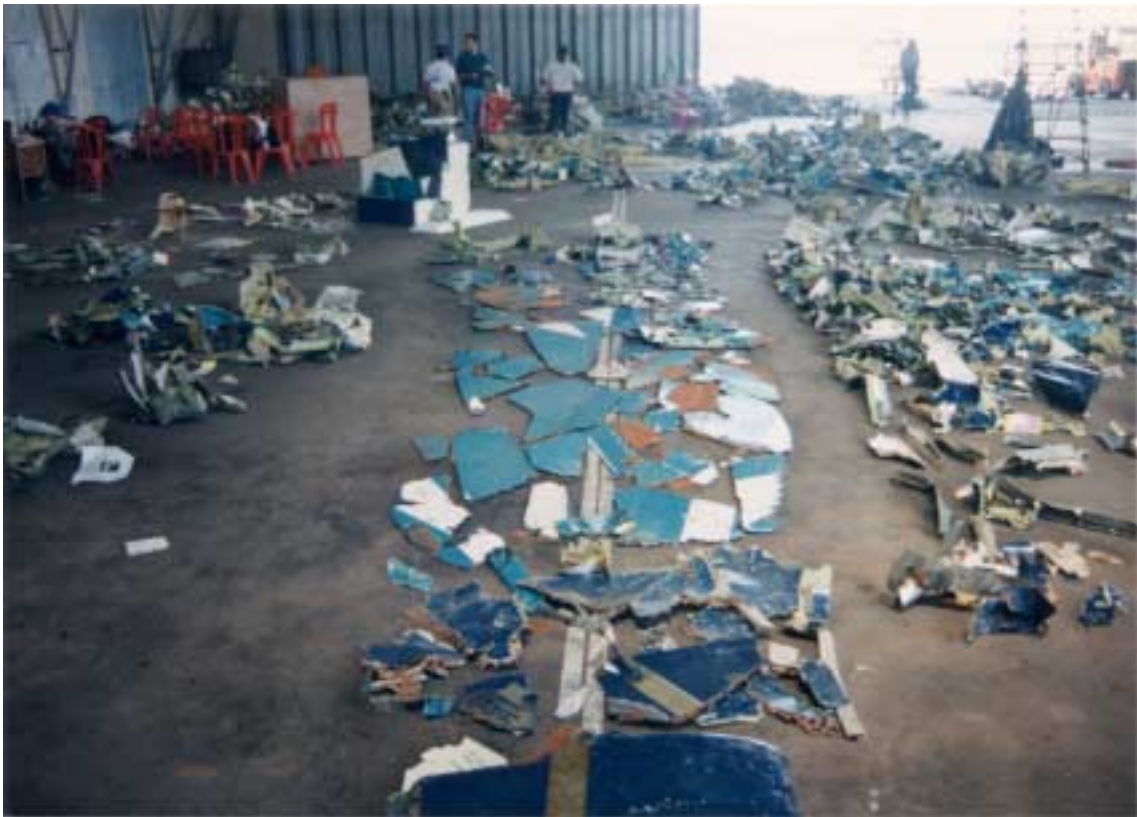
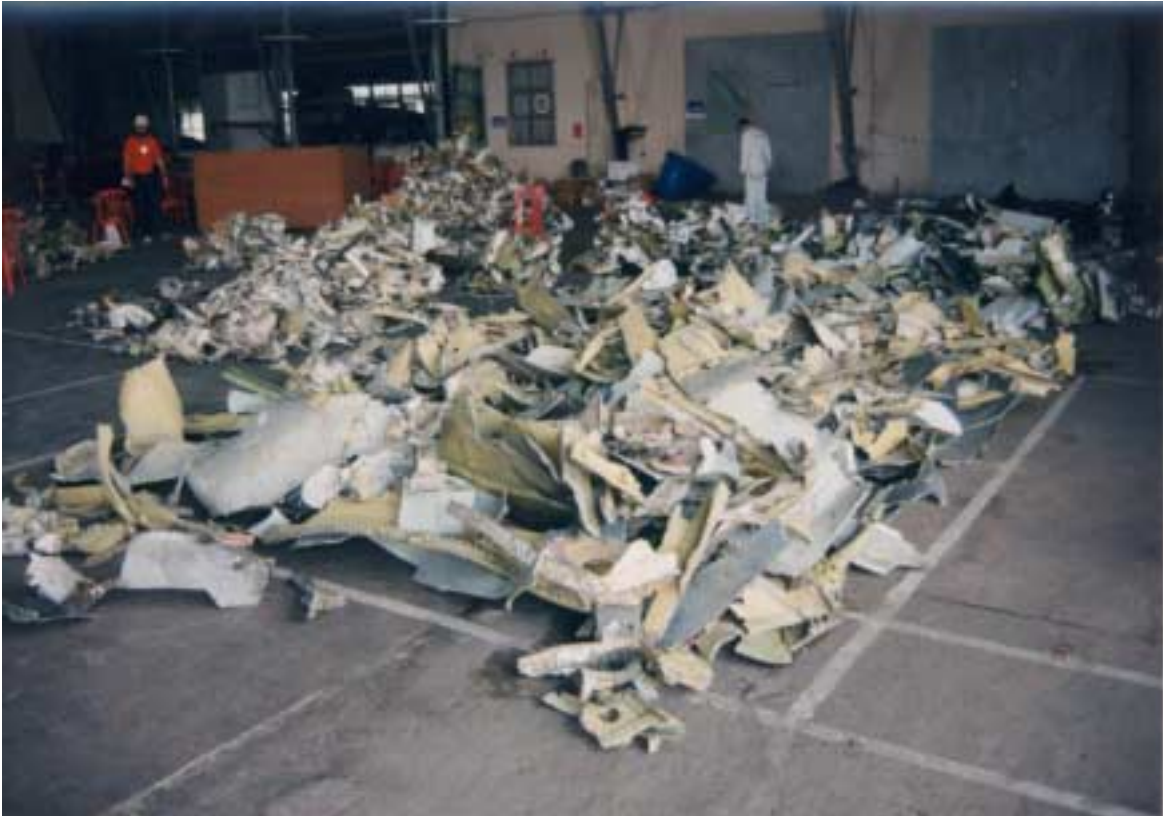
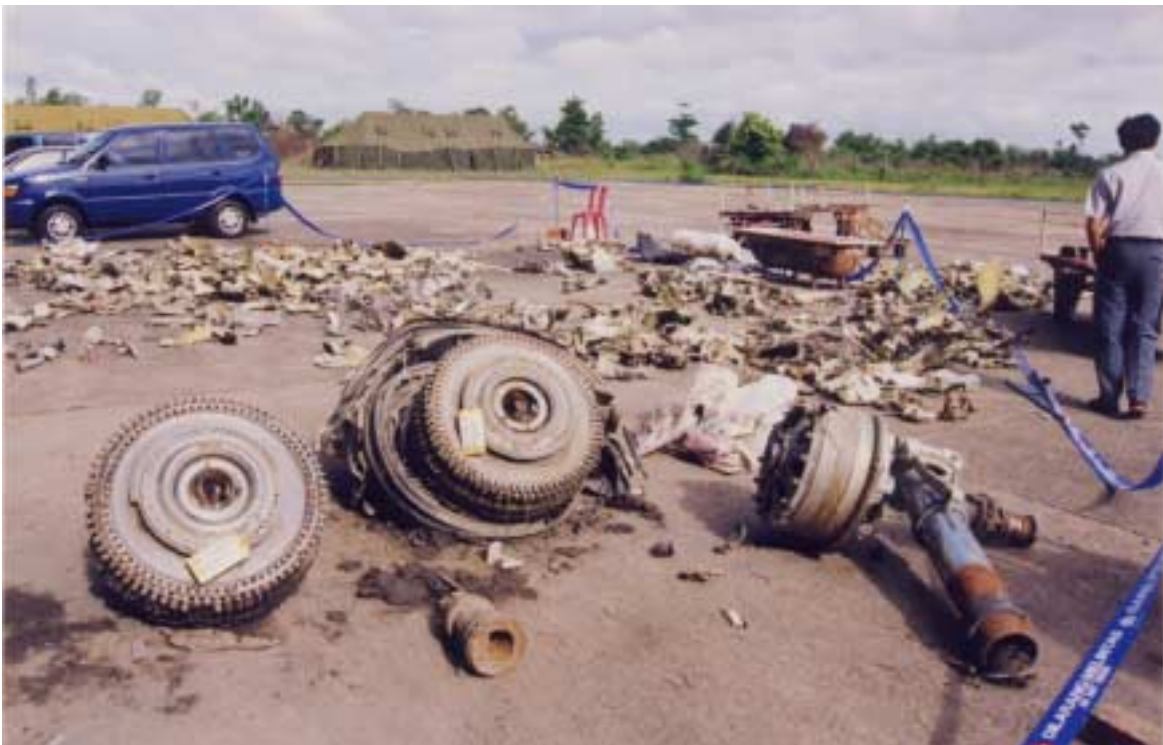
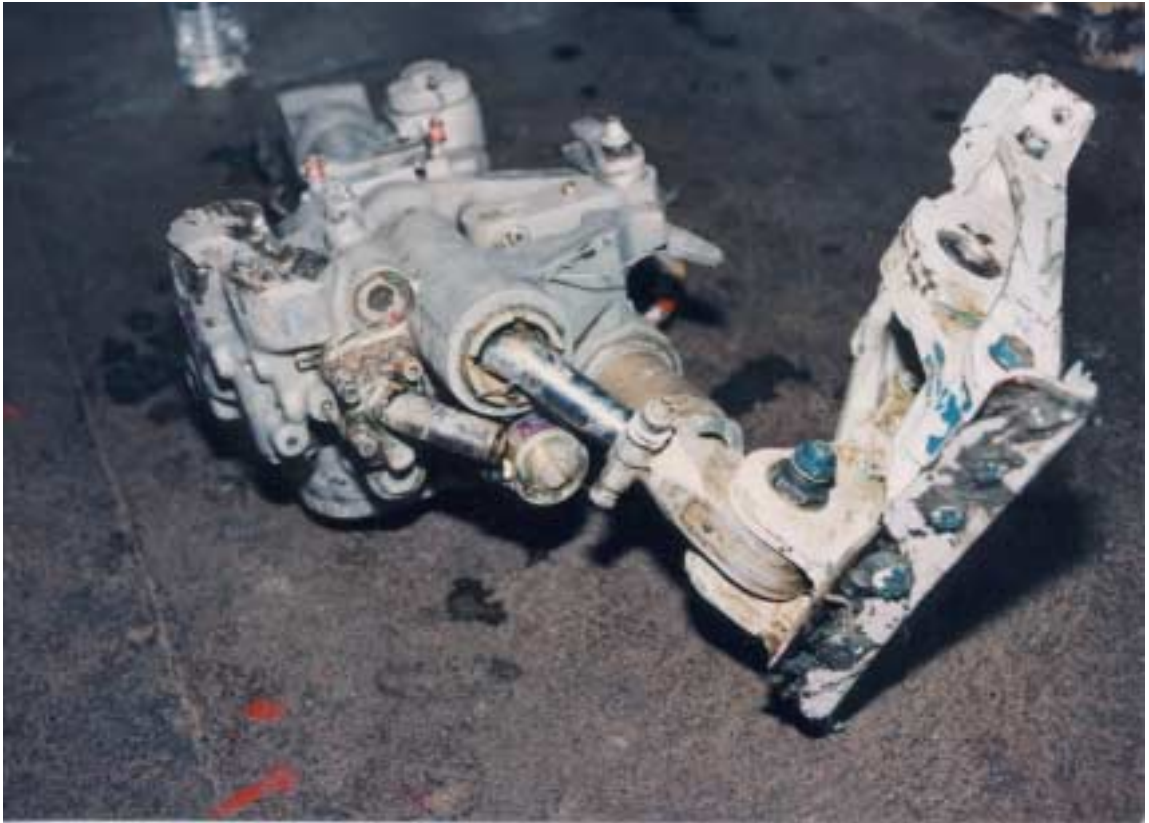
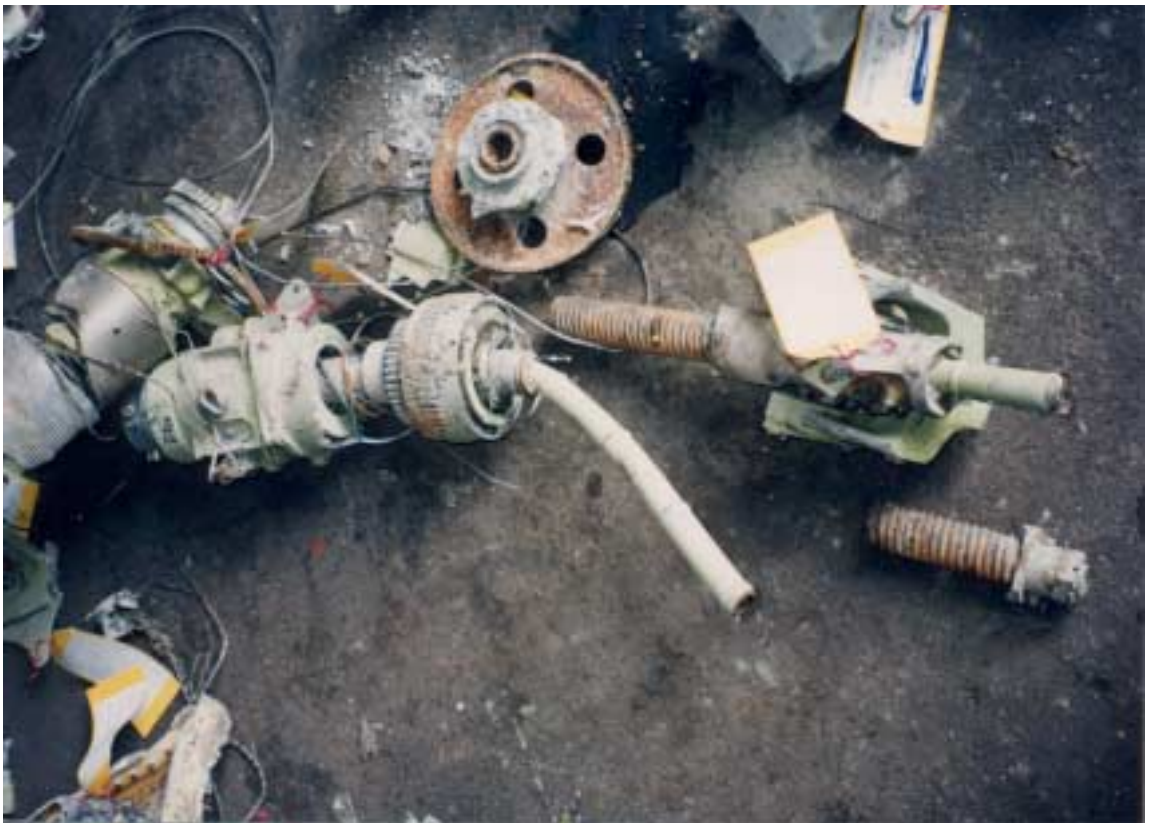
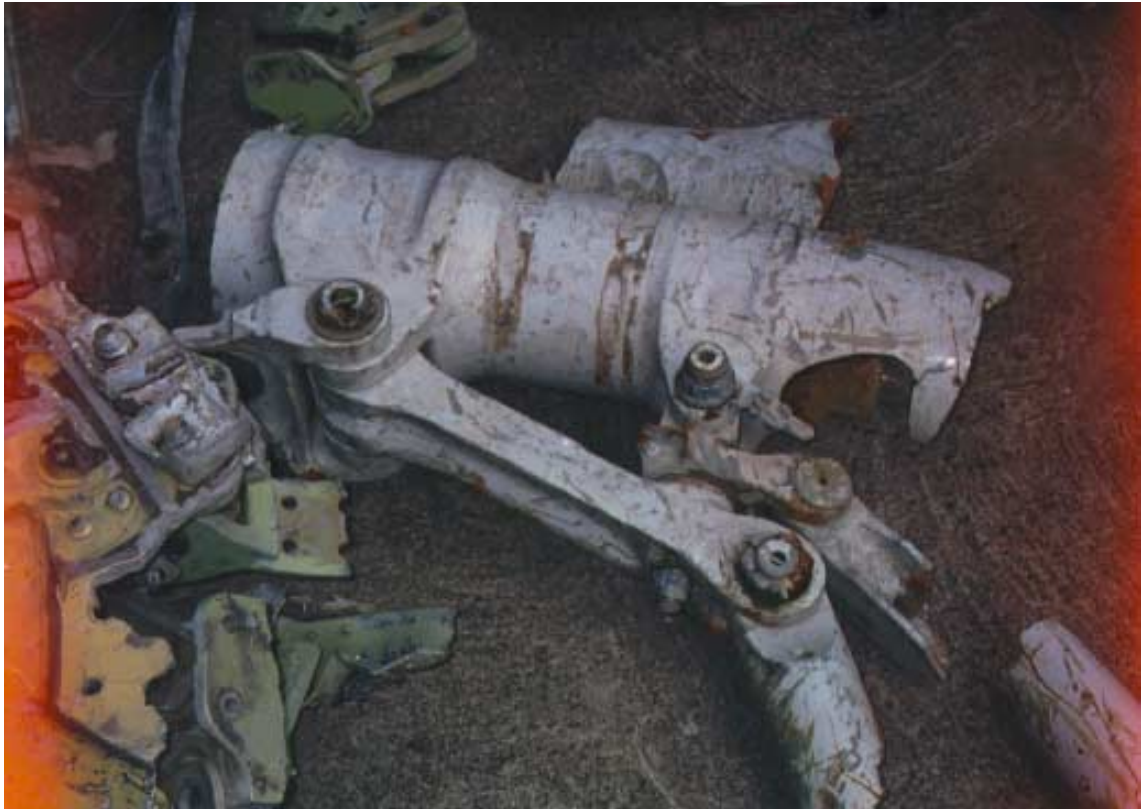
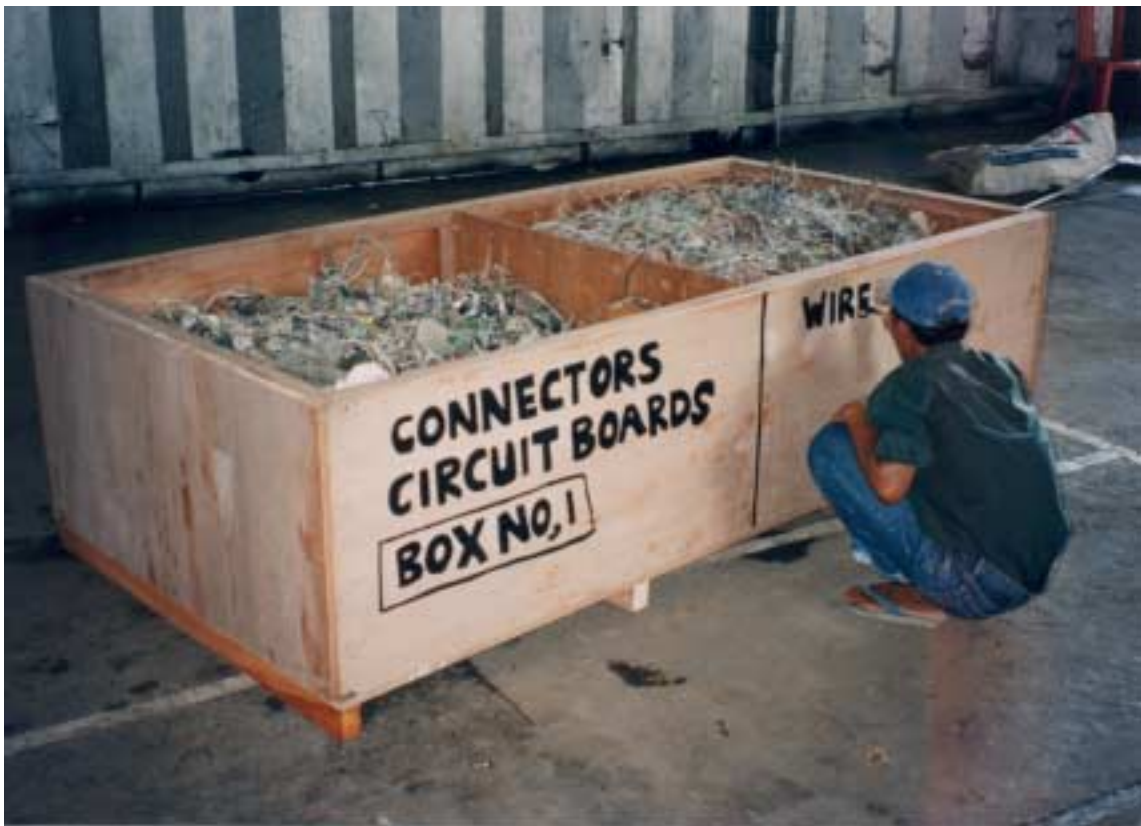
Figure 8 Picture of the wreckage recovered from the river

The aircraft parts found in the river were highly fragmented and mangled on impact, see Figure 8. As a result, all parts of the aircraft were mixed together on recovery, making sorting and identification of the many small pieces difficult. Particular attention was paid to finding parts of the control surfaces, actuators, electronic and avionics systems, engines, Section 48 (rear fuselage including aft pressure bulkhead) and the empennage (see Figure 10). The cockpit instrumental panel and circuit breakers panel were not recovered. The wing flaps, spoilers, ailerons, and leading edge slats and their supporting tracks, carriages and actuation systems were also accounted for. Cabin items such as seat structures, cushions, oxygen generators, etc. were also recovered and examined. Parts and components recovered were contaminated, stained and showing accelerated corrosion. River water and mud samples were taken to determine their effect on the condition of the recovered parts and components. Following cleaning, the parts were marked with the date and method of recovery (by diver or dredge). Where possible, parts were identified, part numbers noted and components were laid out in groups by sub-assembly, for example, wings, landing gears, etc. Empennage parts were laid out on the hangar floor in their approximate respective positions. Reconstruction was limited due to the degree of destruction of the aircraft.

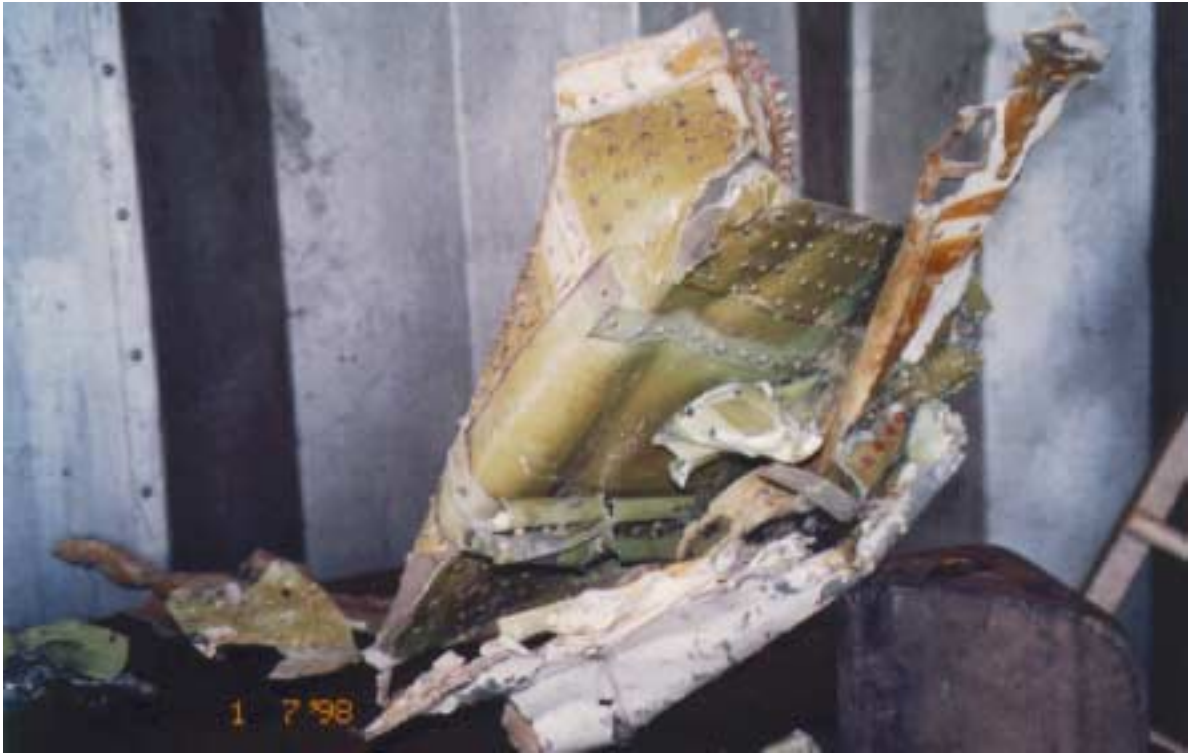
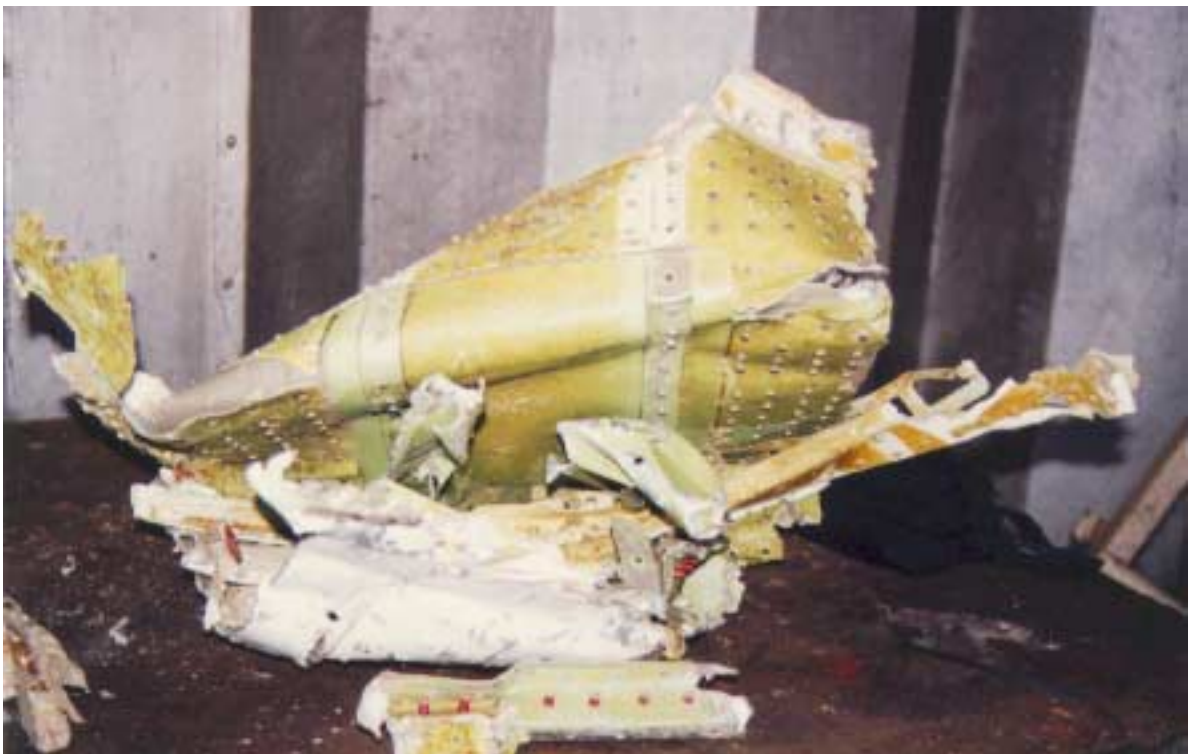
Figure 9 Picture of wreckage of the fuselage skin patch repair

The patch repair was just above the floor level and forward of the left hand aft passenger door between station 867 and station 907 and between stringer 14L and stringer 17L. The entire patch was found intact and was still attached to the surrounding skin, see Figure 9.

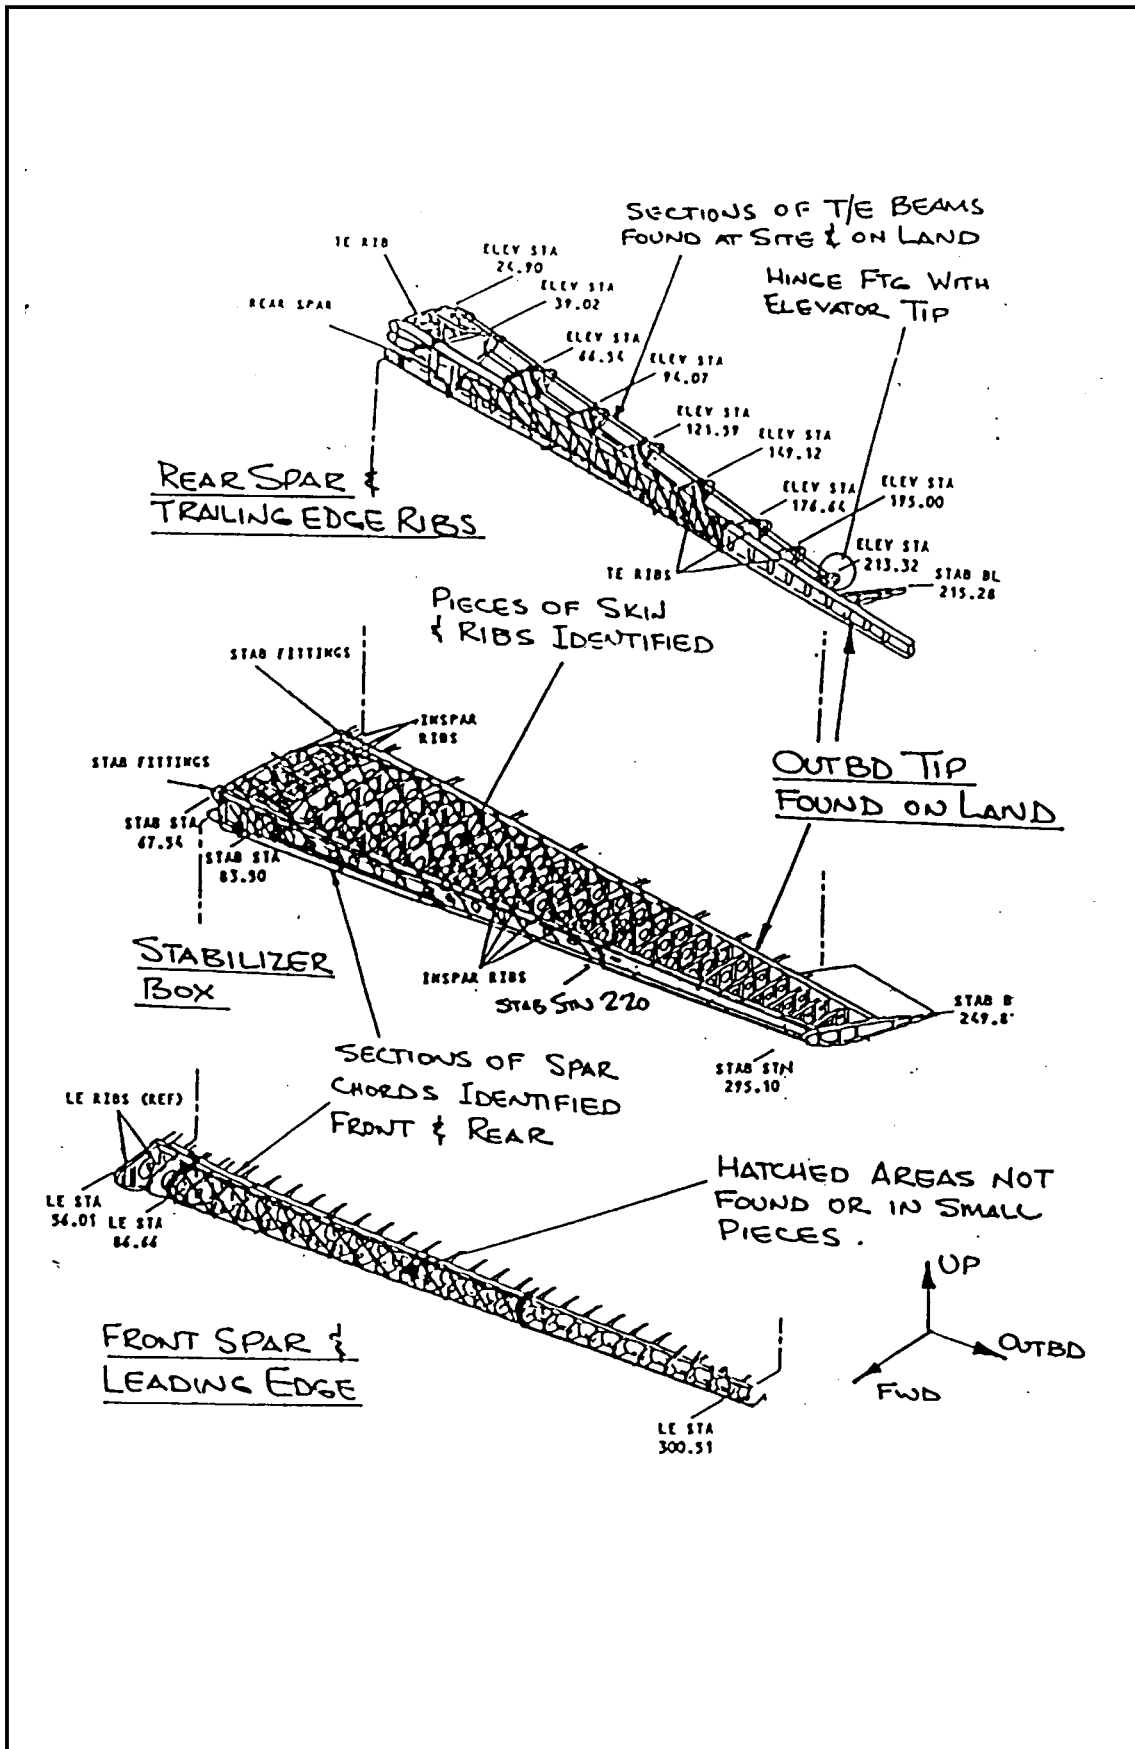
Figure 10.b Horizontal Stabilizer L.H. Side

Left hand horizontal stabilizer (Figure 10.b) - No impact marks were found or observed on the leading edge of this section. Both the front spar (upper and lower chords) and the rear spar upper chord were bent up near their fracture locations. The lower chord fracture was indicative of tensile failure but little deformation was observed. The rear spar web was crushed upward near the fracture location. The upper skin near the fracture was bent up. The upper skin of the leading edge and the interspar areas exhibited wrinkles. The rear spar web of the outboard left hand horizontal stabilizer section contained diagonal tension wrinkles, distortions and paint failures at several locations similar to the right hand horizontal stabilizer outboard sections. As on the right hand horizontal stabilizer, the

damage observed on the outboard left hand horizontal stabilizer section was consistent with high vertical and torsional loading. It is noted that the right hand horizontal stabilizer was severely deformed in the same approximate location as the left-hand horizontal stabilizer chord-wise break near station 221. The stabilizer front spar outboard of station 221 is a solid web, but inboard of this location, the front spar contains flanged lightening holes.

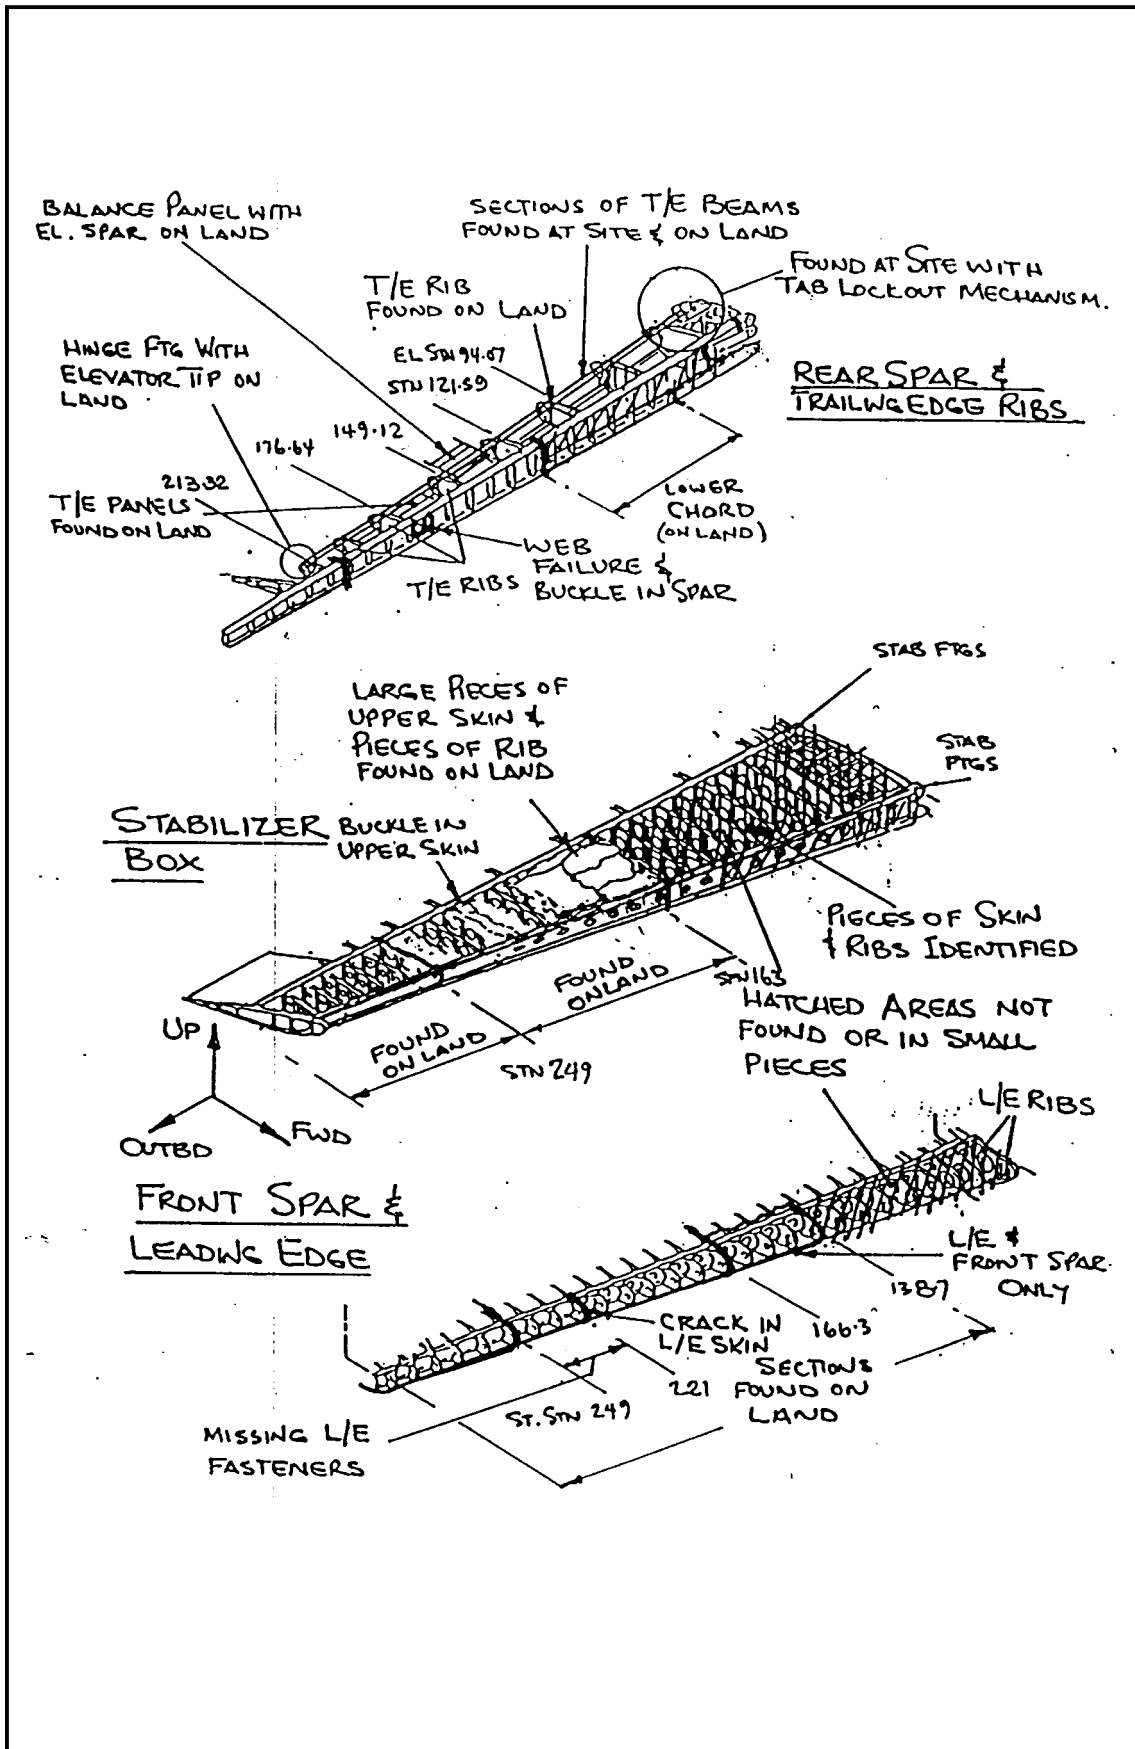
Figure 10.d Horizontal Stabilizer R.H. Side

Right hand horizontal stabilizer (Figure 10.d) - The leading edge of the two right hand horizontal stabilizer sections showed no impact marks. Distortion and wrinkles were noted in the outboard areas of the horizontal stabilizer leading edge and interspar ribs and skin.

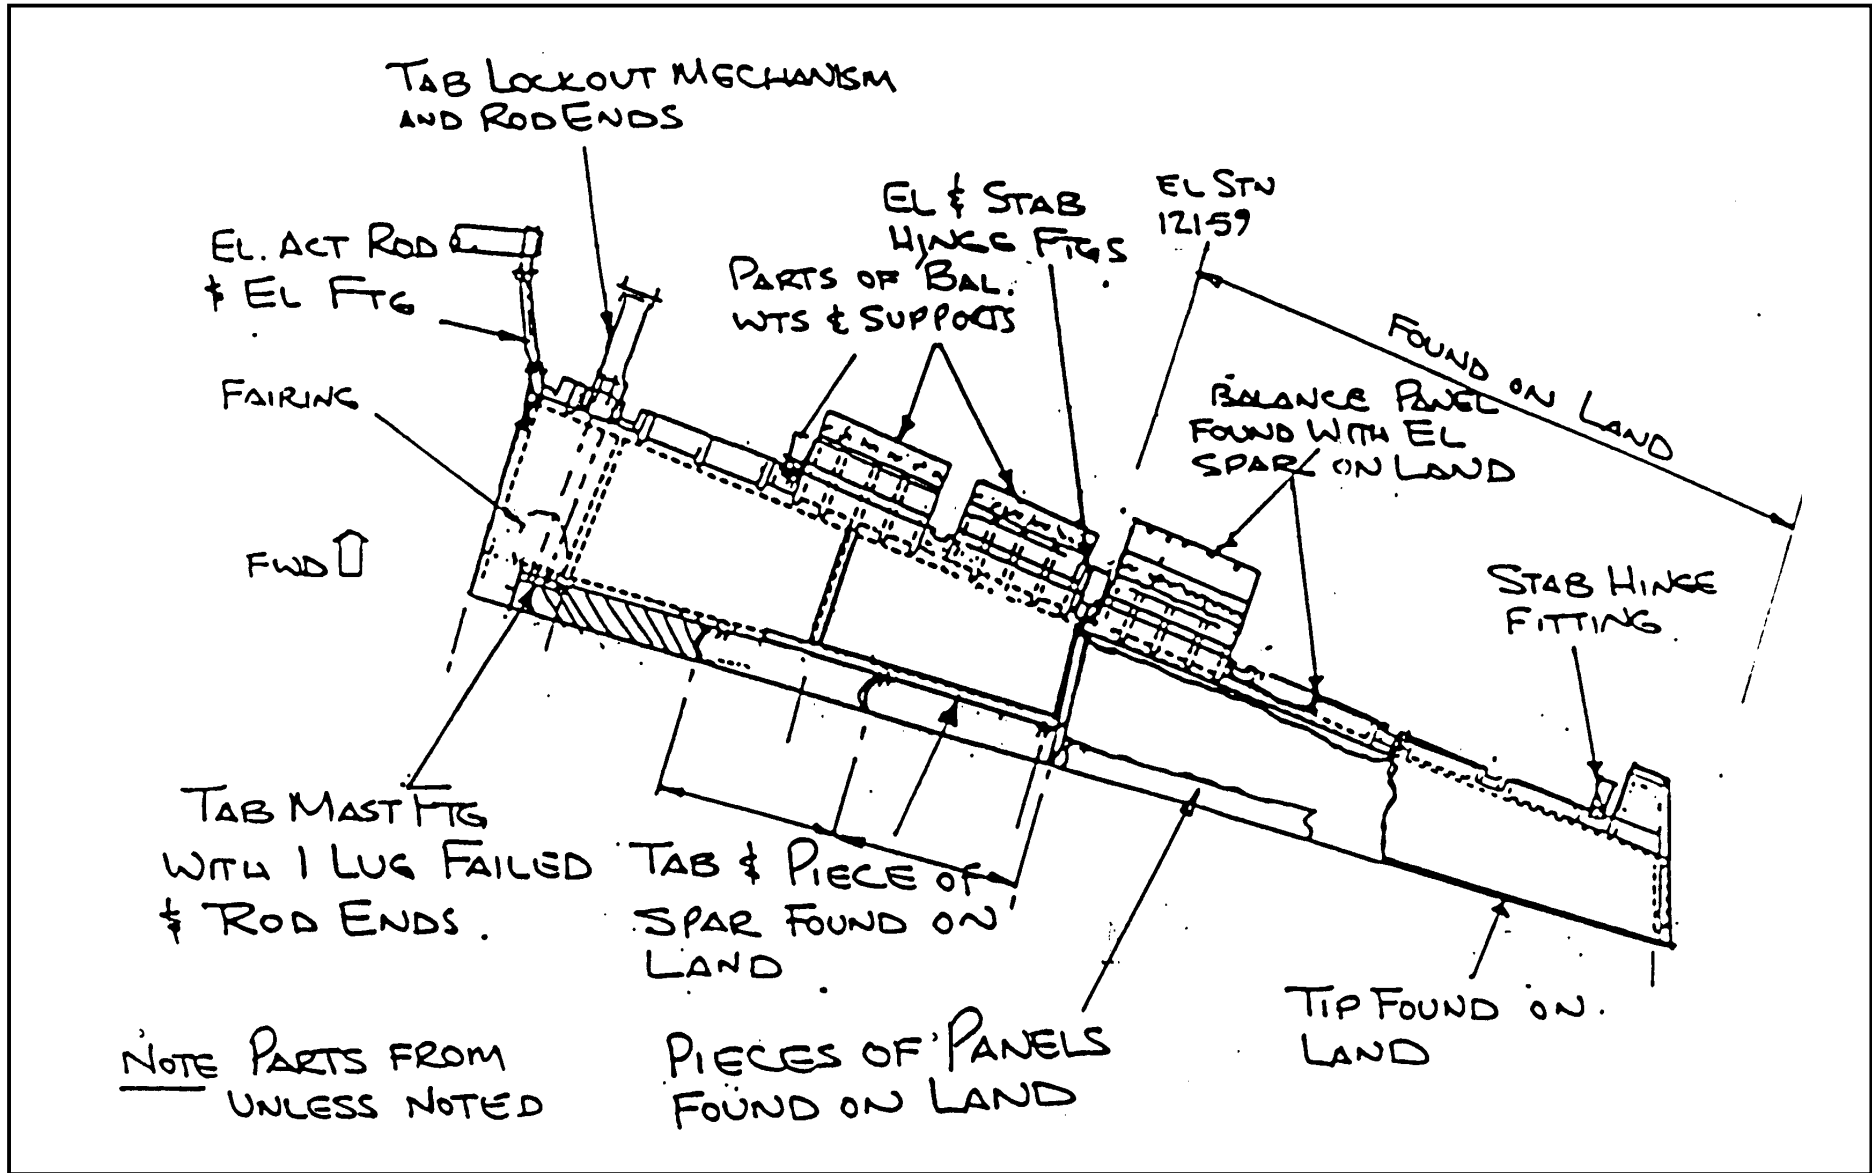
Figure 10.e R.H. Side Elevator

Right hand elevator (Figure 10.e) - All of the control tab pieces were identified except for the portion inboard of elevator station 66. The largest piece of the right hand elevator was the portion from the tip to elevator station 176, including the tip balance weight and elevator station 213 hinge fitting. All six elevator hinge fittings were identified. The hinges located at elevator station 121 and outboard were found on land. The elevator hinges and surrounding area at elevator stations 213 and 176 contained evidence of elevator over-travel in the up and down directions and twisting of the bearings or hinge plates. The bearing and the bearing plates of the elevator hinge at elevator station 195 were twisted as if the elevator outboard end moved upward relative to the horizontal stabilizer. Although the lower bolt was not found, evidence indicated that the bolt was present during the separation of the elevator. The balance weights in the balance bay and support structure were recovered from the crash site. The right hand elevator control tab rods were identified. Deformation of the rods at the right hand elevator showed that they

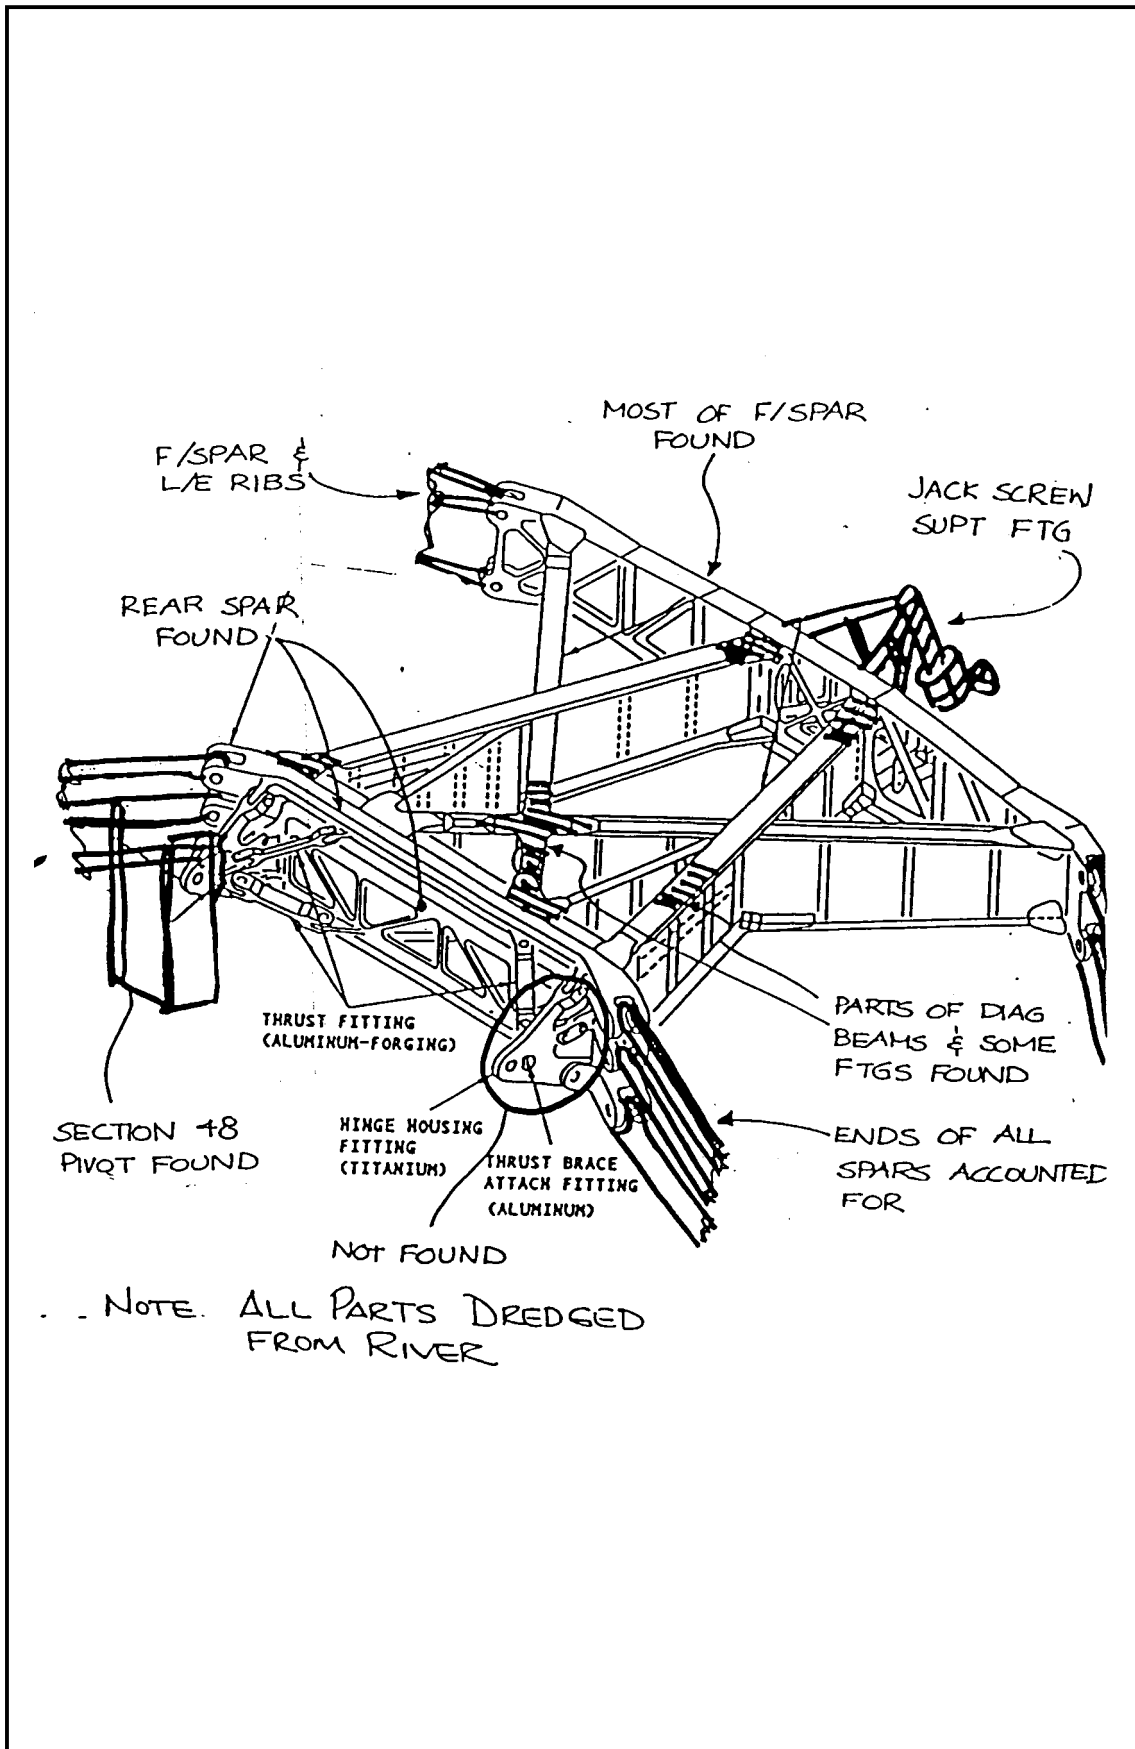
Figure 10.f Horizontal Stabilizer Center Section

The horizontal stabilizer center section (the so-called "Texas Star") structure and the horizontal stabilizer jackscrew were recovered from the crash site in the river. The majority of the front and rear spars were found and identified. The horizontal stabilizer center section has two hinge supports at the rear end about which the horizontal stabilizer is pivoted. The front end of the Texas Star structure is connected to a ball-nut on the jackscrew which is used to move the horizontal stabilizer (Figure 10.f).
